INVESTIGATION OF EFFECT OF HYDROGEN
SNOW ACCUMULATION ON THE
CENTAUR RETROMANEUVER AND
THE SURVEYOR PAYLOAD

Contract NAS8-5623

Pratt & Whitney Aircraft
FLORIDA RESEARCH AND DEVELOPMENT CENTER

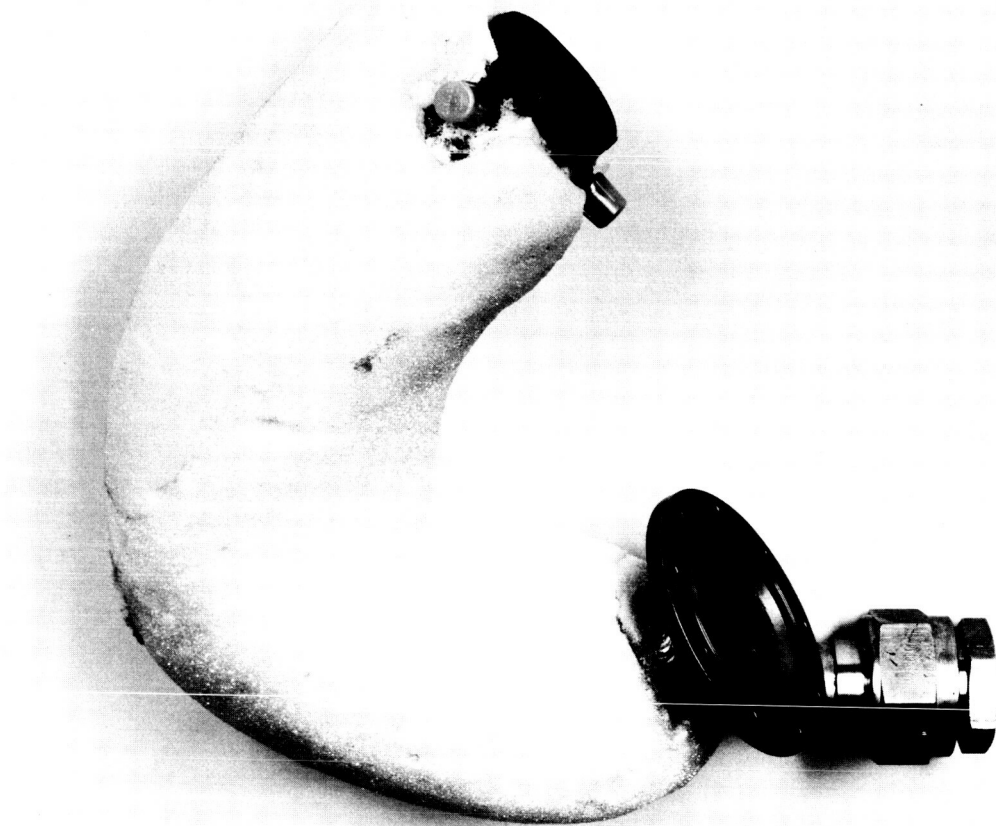
Figure II-4. Interstage Valve Vent Tube with
Teflon-Filled Interior Insulation

Run No. 143.10 was conducted with the interstage vent tube internally coated with Teflon-filled Kel-F. No significant reduction in snow buildup was observed due to the smooth interior surface or any insulating values of the Teflon.
